AMD-768TM

Peripheral Bus Controller

Revision Guide

Publication # 24472 Rev: C Issue Date: March 2002

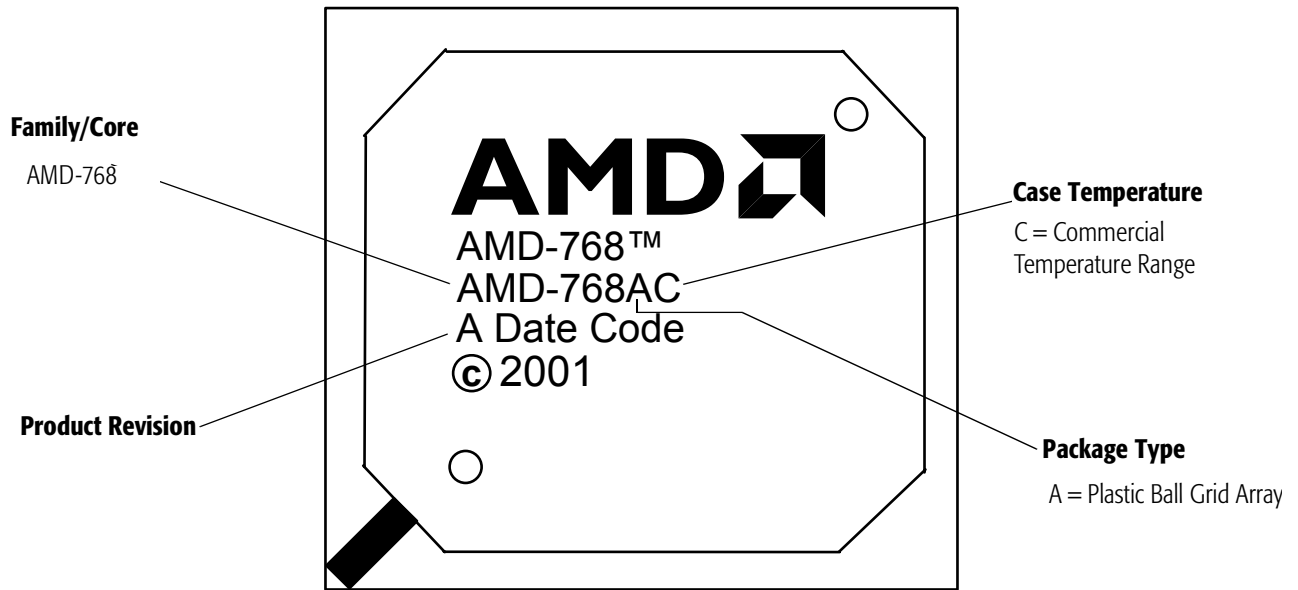
1 Product Marking Identification

- **Product Marking Identification:** This section, which starts on page 5, provides product types, product revisions, OPNs (Ordering Part Numbers), and product marking information.
- **Product Errata:** This section, which starts on page 6, provides a detailed description of product errata, including potential effects on system operation and suggested workarounds. An erratum is defined as a deviation from the product's specification. A product errata may cause the behavior of the AMD-768 peripheral bus controller to deviate from the published specifications.
- **Revision Determination:** This section starts on page 15.
- **Technical and Documentation Support:** This section, which starts on page 16, provides a listing of available technical support resources. It also lists corrections, modifications, and clarifications to listed documents.
